DN1600 Metal Expansion Joint produced in two days

Service: Eliminate effect of outside corrosion

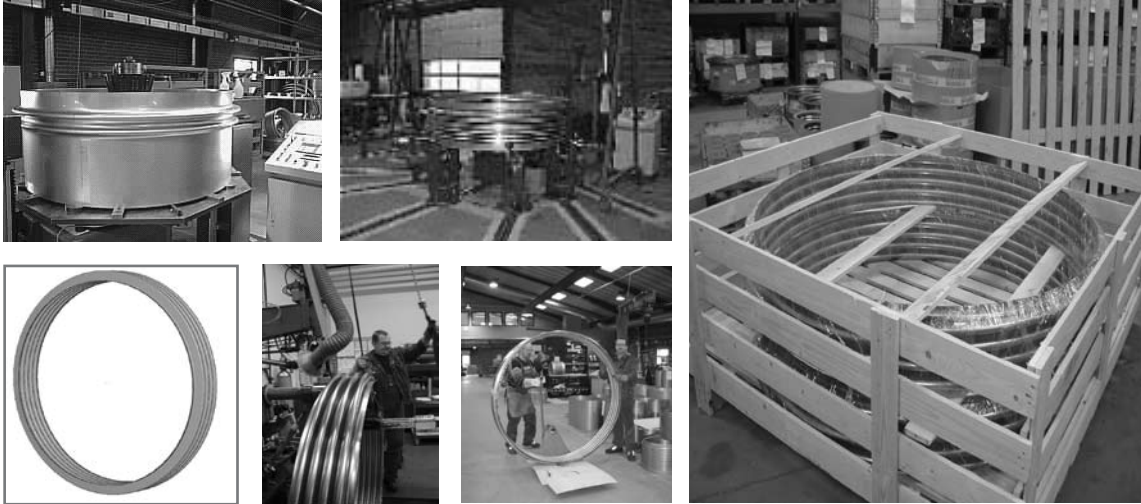
Pressure range: Medium/high	Medium: Brine
Temperature: 110°C	Country of installation: Dubai
Movements: Lateral	Country of placing the order: Dubai
Dimension: DN1600	
Bellows Material: Incoloy 825

A leaking bellows in a desalination plant. KE-Burgmann Bredan inspects the bellows on site: the customer needs a quick repair of the bellows. Normally a clamshell solution is proposed: an oversize clamshell expansion joint seals a leaking bellows while keeping the plant on line at emergency situations. However, in this case welding on the run is not possible. Instead we suggest a fast turnaround refurbishment of the expansion joint. The customer approves our designs and the scope of work and tools required is controlled: a very tight programme is compiled. Our engineers starts up designing the bellows over weekend. Production of the bellows starts sunday night and tuesday the shipment of 6 expansion joints are airfreighted to the customer. KE-Burgmann Bredan sends out a welder to weld and inspect the installation together with the local welders to ensure a correct installation.

All the activities from the first contact with the customer to delivery of the bellows is made in less than one week.
